## Service Bulletin

**Subject:** TS-50S Lithium Battery Replacement Notes

**Subject:** TS-50S "HELLO" Displayed during TX

**Subject:** TS-50S Antenna Lead Wire

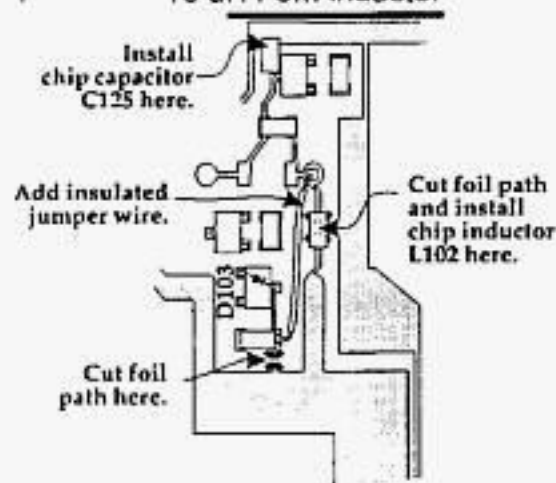
Final Unit (X45-3460-00) (B/2)  
Foil side View

Occasionally an "HELLO" message will appear in the display of the transceiver when the TS-50S is loaded into an antenna without the use of an antenna tuner. This symptom usually occurs when the negative terminal of the power supply is floating (un-grounded for RF). This can result in RF feedback that causes the supply voltage to exceed 16 vdc.

1. Cut the Final Unit PC Board foil in two places, as shown below.
2. Add a .1uF chip capacitor (C125) as shown below.
3. Add a 10 uH chip ferri-inductor (L102) as shown below.
4. Add an insulated jumper wire as shown below.

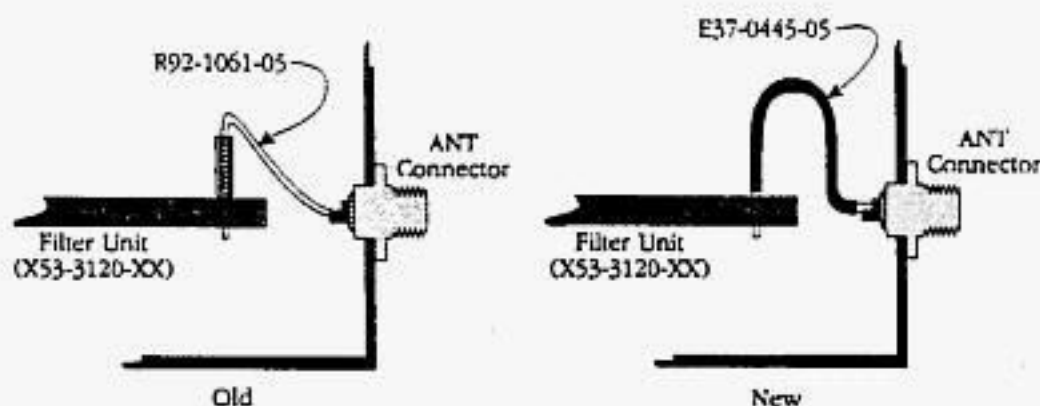
Several users have reported a problem with the antenna lead connection, i.e. the lead that connects the antenna connector to the Filter Unit (X53-3120-XX). Originally this connection was made by a zero ohm resistor. If excessive stress is placed on the antenna connector this lead is easily broken, with a resulting loss of receiver sensitivity and transmitter power. The use of a small flexible jumper wire will increase the flexibility of this connection, thus minimizing the effects of mechanical stress.

Remove the zero ohm resistor and replace it with the small piece of cable. See accompanying diagram.

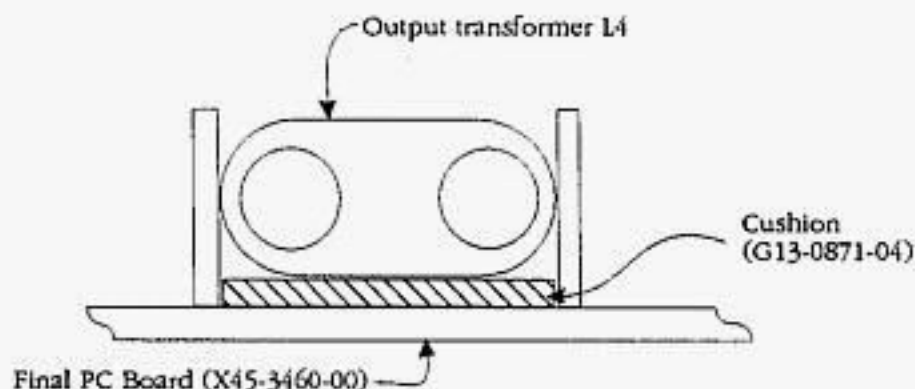
When the transceiver is subjected to vibration a mechanical noise can be heard from the output transformer area. This has led to concern by several consumers that something is loose or improperly installed.

In order to ease consumer concerns you should add a cushion under transformer L4 as shown in the accompanying diagram, and replace transformer L13 at the same time. This transformer has been fastened to the circuit board with high temperature adhesive, so use caution when removing it from the circuit board.
