# SERVICE BULLETIN

SUBJECT: Model TS-700A

DATE 12/28/77

Replacement of 9V regulator IC  
MFC-4060 with improved MC1723CL-A

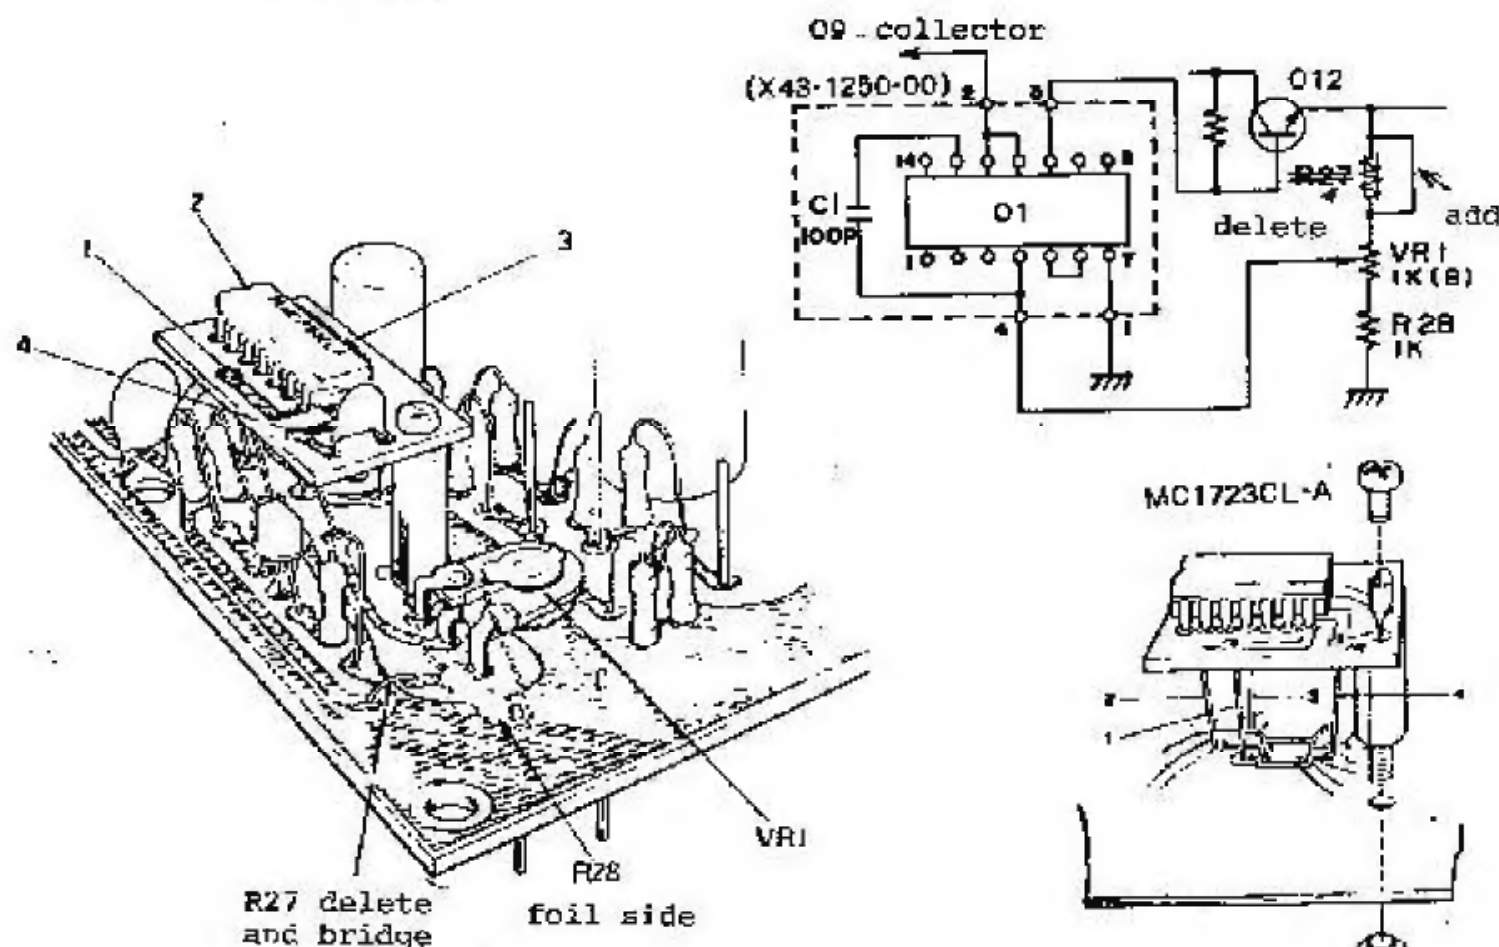
X43-1250-00 P.C.B. Comes complete with mounting hardware and extended leads for easy installation.

1. Remove old IC MFC4060-A Q11
2. Remove R27 1.5kohm (delete,). Replace with wire jumper.
3. Remove and reinstall R28 1kohm on foil side of P.C.B.
4. Mount P.C.B. per illustrations (observe lead call-outs between X43-1250-00, new P.C.B., and old Q11 position (X43-1120-00)).
5. Reset VR1 for 9.0V measured at power supply output terminal.
6. Reset VR2 for 21.0V measured at power supply output terminal.
