## TS 940 Mods

### Expanded xmit for Kenwood TS-940S

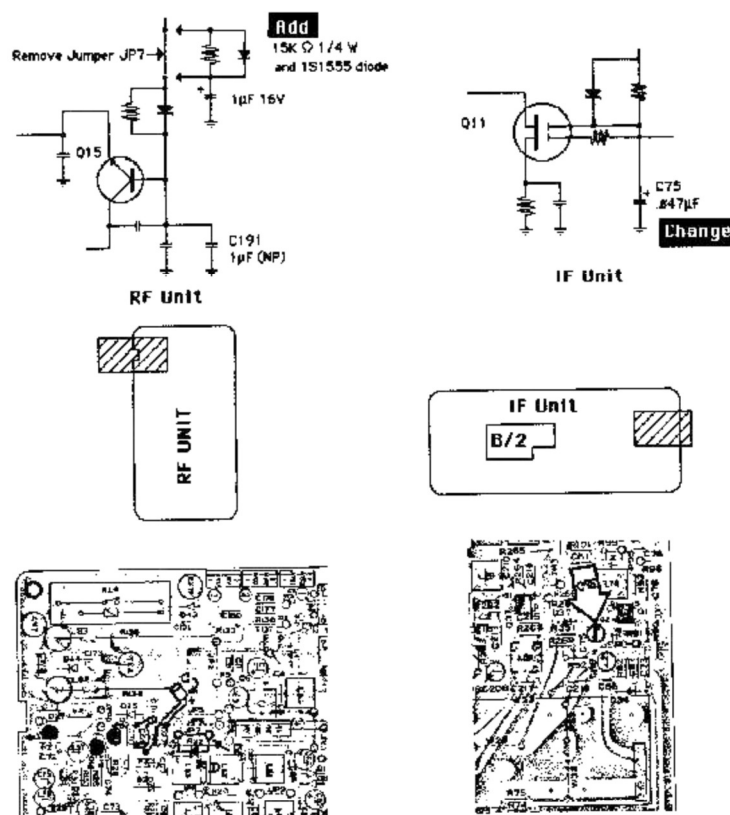
The following changes will improve the adjacent rejection of the TS-940S when a relatively strong nearby signal is present (s-4 or above).

1. Remove jumper wire JP7 and replace it with the parallel combination of the 15 Kohm resistor and the 1S1555 diode. Pay close attention to polarity.
2. Add the 1 µF capacitor as shown in the diagram.

Change capacitor C75 from a 1 µF 50V capacitor to a .047 µF 50V capacitor.

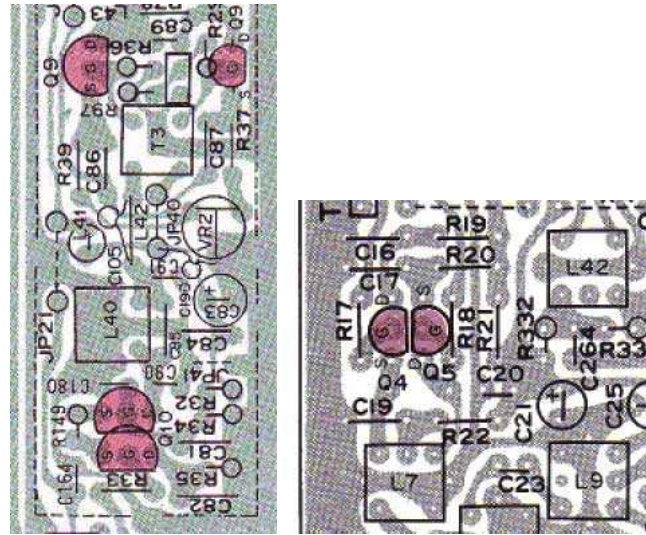
*See the FETs Q10 (RF Preamp Preamp 2SK125, N-FET, 25V, 0.1A, 0.3W) and Q4 Q5 (2nd balanced mixer, also 2SK125). The picture above was scanned from the TS-940S Service Manual, Revised Edition. In these pictures the FETs are in the wrong position.*

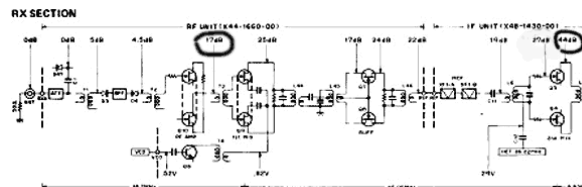
*See the Level Diagram in the Service Manual. With the FETs on the right position, we would have 12.5 dB (17 - 4.5) gain in the RF Preamp, and 17 dB (44 - 27) in the 2nd balanced mixer at the indicated points in the picture above. It would be interesting to measure these gains before the correction. With this measurement we would have an idea about the sensitivity losses due to the two errors.*

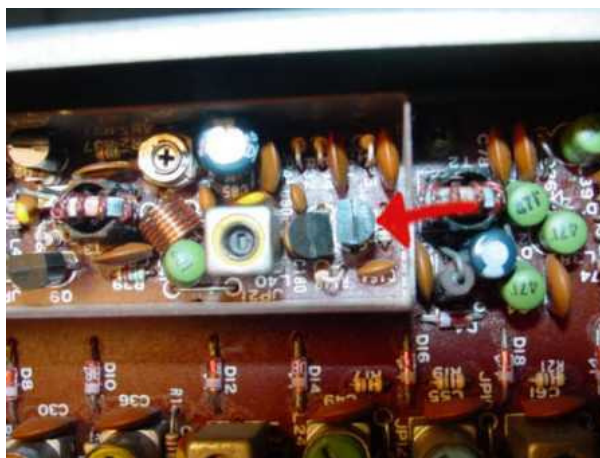
My radio was working apparently well. This is the 1st TS-940S that I could observe and analyze in detail its circuits. First I found the RF Preamp FET in a odd position, but only few days after I could focus and see that the cascode circuit was correct in the schematic diagram and wrong in the PC board. It was also wrong in the PC board view pictures in the Service Manual.

I also noticed that a FET was hotter than the other. It was as simple as disordered and turn the FET 180° and resolder it all over again.

*This picture shows the FET in the correct position.*

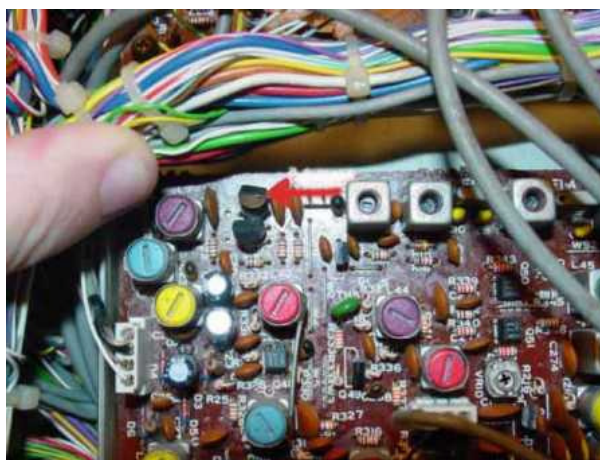
I got back to the Service Manual, and following the circuit diagram, checking the PC boards, I found a second mistake: in the 2nd balanced mixer, in the IF unit, another inverted FET (Q4), harming the mixing/conversion, the gain, and the AGC performance.

*This picture shows the FET in the correct position.*

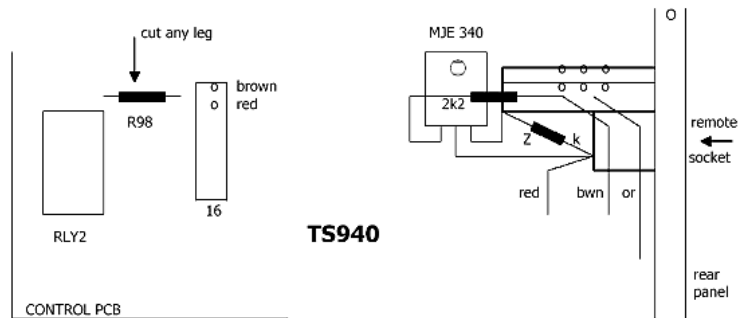
After many years of service the relay RL2 that activates the PTT to a linear amplifier can become unserviceable and its replacement is an elaborate process involving the complete removal of the Control PCB. All this can be avoided by substituting the relay with a transistor that can be mounted physically on the Remote Socket and only one resistor leg needs to be cut on the Control PCB:

For use with a TL922 amplifier it is necessary to use a high-voltage transistor such as the MJE340 and a zener diode of 150V as it has a 100V DC relay coil that must be grounded for TX operation. This modification will work on any amplifier requiring pull-down for TX. If the pull-down is only for 12V, the zener diode voltage can be lowered to 15V or eliminated all together if there is no relay.

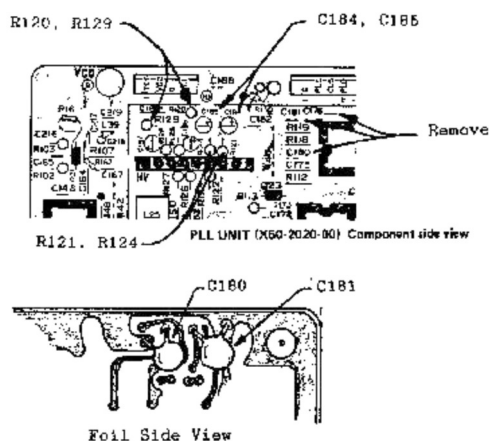
### PLL UNIT

The Carrier to Noise ratio of the TS-940S may be improved by the following changes. This bulletin supersedes bulletin number 911 dated September 15, 1986.

On the PLL unit (X50-2020-00) remove capacitor C176, C180, and C181. Change resistor R120 and R129 from 470 ohms to 3.3 Kohm. Change resistor R121 and R124 from 1 Kohm to 680 ohms. Change capacitors C184 and C185 from .22  $\mu$ F to .33  $\mu$ F 35V tantalum capacitors. Install C180 and C181 in the positions shown in the accompanying diagrams. The use of new capacitors is recommended to improve reliability, don't try to reuse the old capacitors! Capacitors C181 and C180 should be attached to the foil side of the PLL unit.

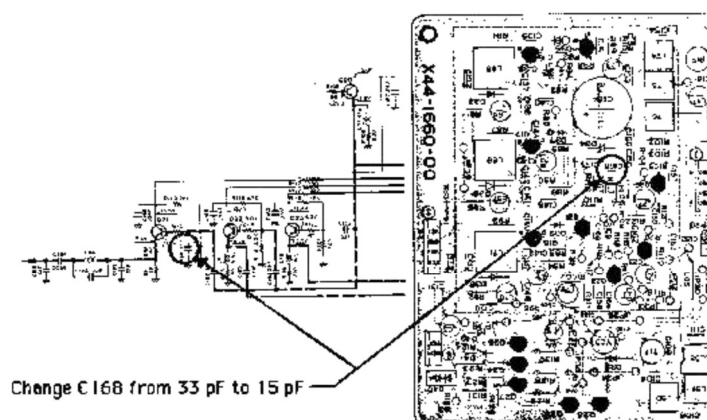
Reports of a PLL unlock on the lower frequencies may be due to low VCO levels. The following change will increase the VCO level and should prevent reoccurrence of this symptom.

1. On the RF unit (X44-1660-00) change C168 from a 33 pF capacitor to a 15 pF 50V capacitor.
2. Readjust the VCO BPF (RF unit L74-76) according to the instructions contained in the TS-940 Service manual.

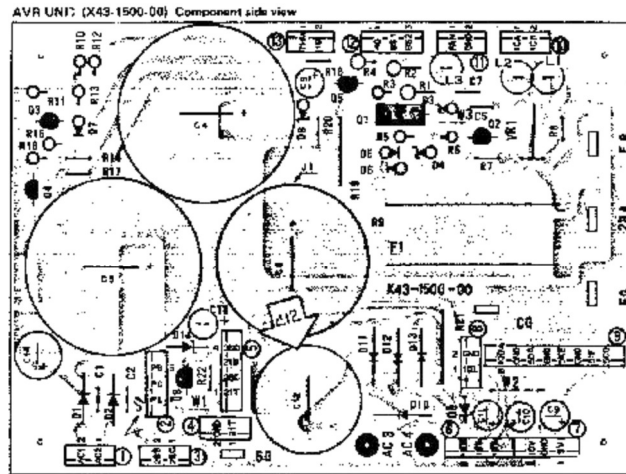
In those areas of the country that are subject to large power line voltage fluctuations, excessive voltage may be applied to capacitor C12 on the AVR unit (X43-1500-00). These voltage fluctuations might exceed the capacitor breakdown voltage. Replacing capacitor C12 with a capacitor having a higher breakdown voltage will help prevent this potential problem.

On the AVR unit (X43-1500-00) change C12 from a 6800  $\mu$ F capacitor to a 5600  $\mu$ F 25 V capacitor (C90-2037-05)
