# Circuit Improvements for the TS-440S

By Richard L. Measures, AG6K

Updated December 2002

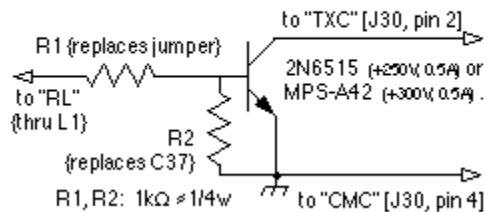
*Amplifier-control relay (RY2) replacement for  
TS-440S SWITCH UNIT, (N41-1610-00) (N-14)*

**PROBLEM:** The amplifier-keying-relay, RY2 on the (N/14) Switch Unit, makes too much noise, or the contacts on RY2 have burned and pitted, or all of the above. Another problem with RY2 is that it is too slow to use with a full-QSK amplifier. This needless make-delay can cause the amplifier to hot-switch, burning the contacts in its QSK-relays. **FIX:** replace RY2 with an NPN switching transistor and fix the current pulse problem that pitted the relay contacts, which may also damage the transistor. [only works for amplifiers with positive voltage relay control]. If your amplifier uses positive 110V for the relay control, like the SB-220 and the TL-922, the relay pitting is caused by the current pulse from the repeated shorting out of the charged .02 $\mu$ F bypass capacitor across the amplifier's relay control jack. The bypass-capacitor can be removed if shielded wire is used for the interconnection cable to the transceiver. Another fix is to install a 150 Ohm to 200 Ohm, 1/4W series resistor at the relay control jack to limit the discharge current to a value that the relay or switching transistor can handle. The bypass

**Transistor Installation Notes:** The N/14 Switch Unit is located just behind the ANT RF connector on the rear panel. The small access panel on the bottom, rear of the radio is removed to gain access to the N/14 Switch Unit. Two chassis-ground connections and one center pin connection must be unsoldered from the RF connector before the Switch Unit can be removed. Unplug the three connectors, remove the two sheet metal screws, and lift out the Switch Unit. Unsolder and remove RY2, D16, and the white jumper-wire and the pin that it plugs into. Install one 1k Ohm resistor each in place of D16 and in place of the jumper-wire and its pin. The transistor will solder in place of the relay if its full length leads are bent to fit the available holes. The emitter goes to common-ground, as does the trace to J30, pin4 [CMC], the ground return for the relay control circuit. The base lead connects to the trace that goes to R2 {D16} and C37. The collector solders to the trace that connects to J30, pin 2 [TXC].
