## TS 940 Mods

### Expanded xmit for Kenwood TS-940S

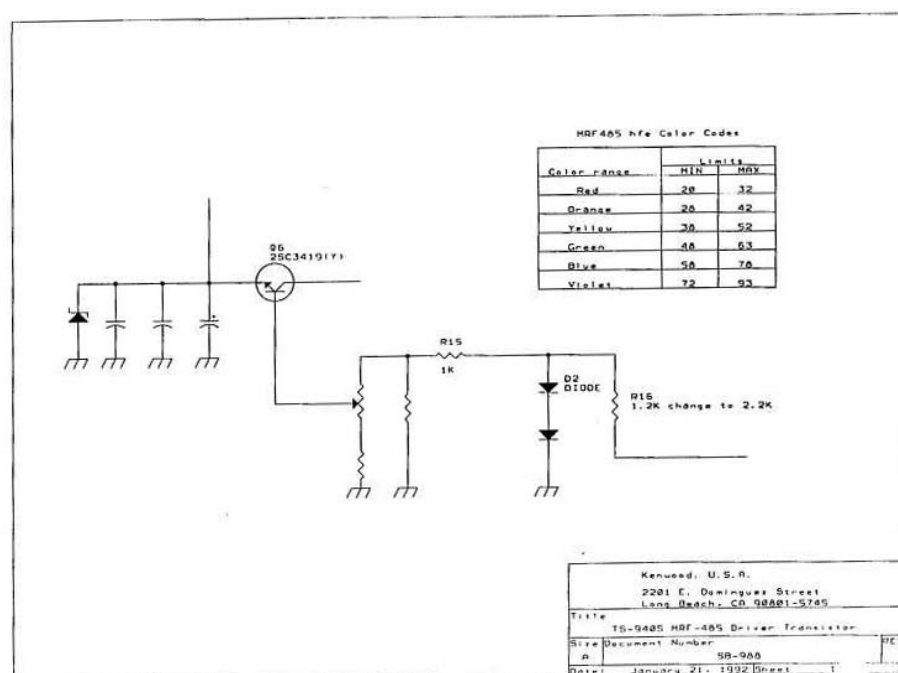
Some MRF-485 transistors are being supplied by Motorola with a Green or Blue color ranking. If these transistors are installed without modifying the driver bias circuit there is a strong possibility that they will fail within a very short time frame.

These high gain transistors cause the circuit to become unstable which can cause the circuit to break into self oscillation, and therefore self-destruct.

**Caution:** If using a Green or higher hfe rank one of the above countermeasure must be taken depending upon the serial number of the set. After replacing the drivers check the bias current. We recommend transmitting for 1 hour in SBB mode with no modulation into a dummy load. After this time frame check the bias current. It must not exceed 300 mA on the original radio. If the current changes you must change R16 from 1.2 Kohm to 2.2 Kohm.

Use of Red, Orange, or Yellow hfe color rankings is recommend. These lower gain transistors work just fine and do not suffer from the circuit instability problem. If you are only able to obtain the high gain transistors you will need to modify the varistor/temperature compensation circuit on the final unit (X45-1400-00) by changing R16 from 1.2 Kohm to 2.2 Kohm.
