This modification has been tested and confirmed for "USA models ONLY", including those with the most recent firmware from revisions from ICOM as of 06-30-2008...

Extended Transmit Frequency Coverage Ranges:

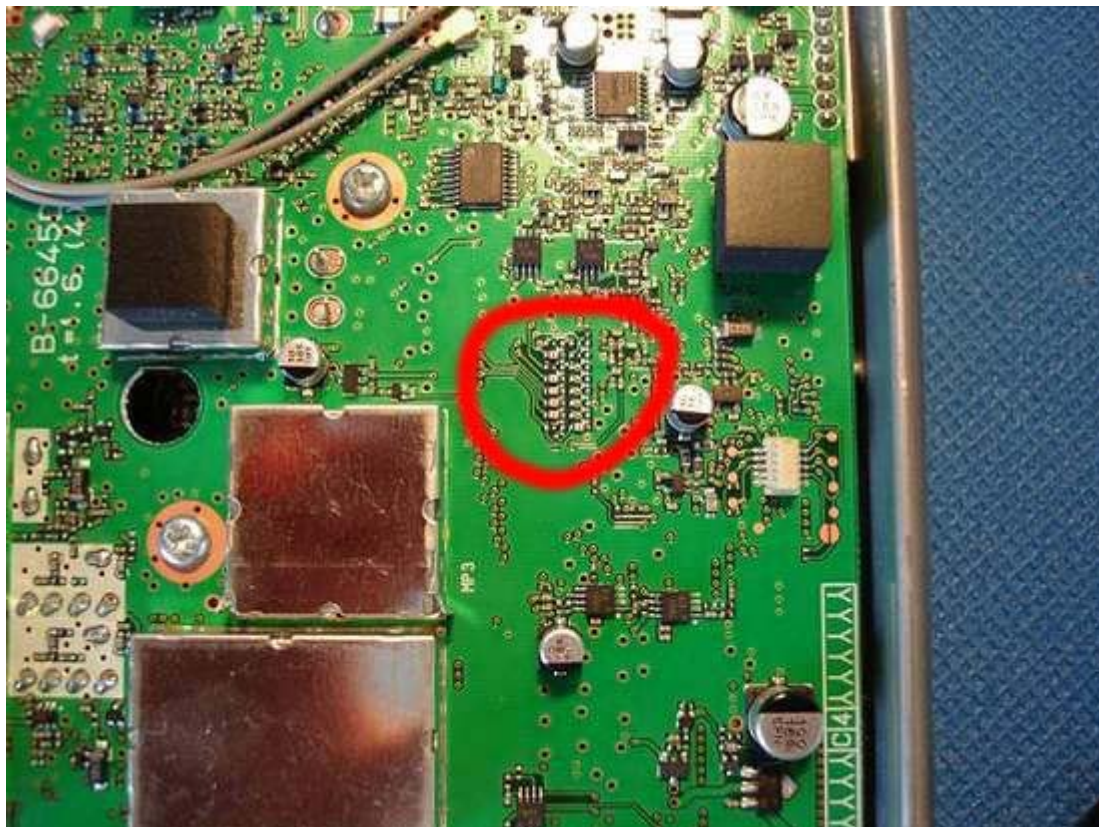
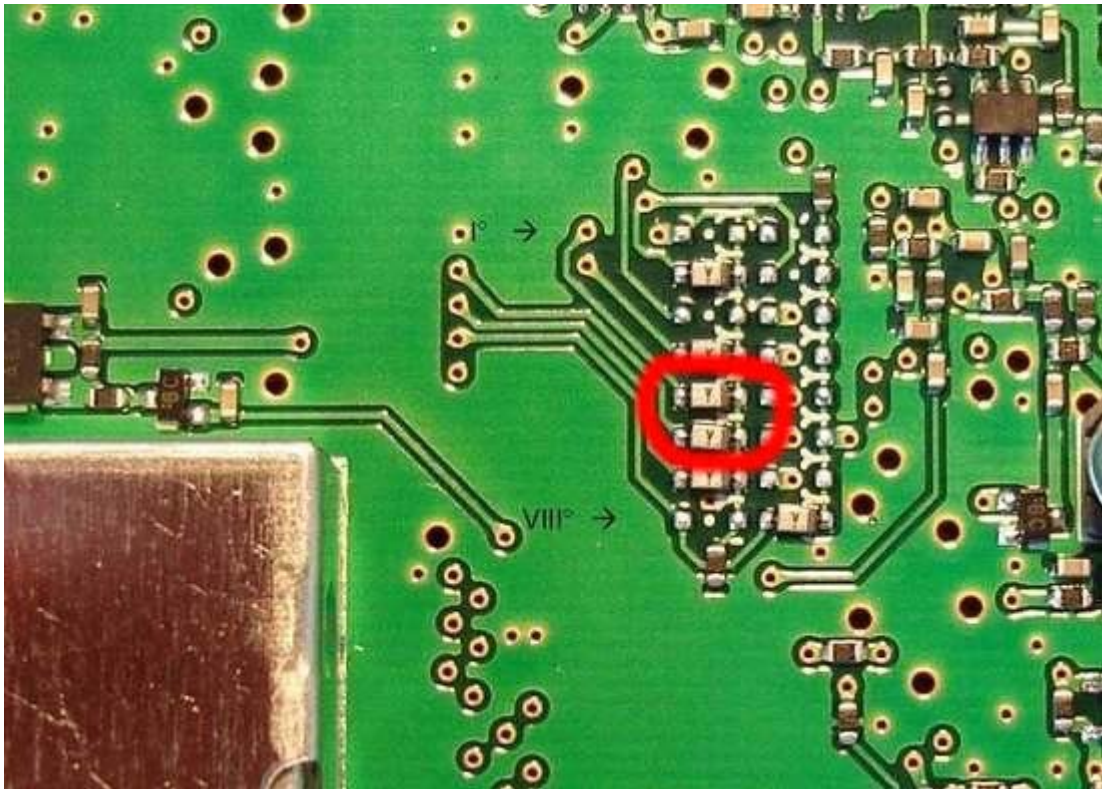
1. Remove the top cover. (This is the side with the serial number sticker)
2. Locate the jumper panel as shown in the photo. (This is the one to the left of the white j-tag firmware uploading connector and to the right of the "VIII" notation on the circuit board)
3. Take note of the jumpers currently in place. On models that the modification has been successful, there have been NO jumpers on the right side of the jumper panel. On the left side of the jumper panel, ONLY jumpers "5", "6", & "7" were in place from the factory.

4. Remove the ONLY the jumpers in positions "5" & "6" counting from the top down on the left side of the jumper panel.
5. Check for loose solder pieces, clean with compressed air and reinstall the top cover.

**Note:** When the modification is completed, you should only have the jumper in position 7 remaining on the left side.
